**Bio-Stimulated Surface Healing of Historical and Compatible Conservation Mortars**

# Bio-Stimulated Surface Healing of Historical and Compatible Conservation Mortars

**Abstract:** The main focus of this research was the bio-stimulated healing of cracks in lime mortar samples (historical and newly designed). The investigation started from comprehensive characterisation of historical mortars, while in the next stage a compatible conservation mortar was designed and characterised, with special attention given to the contact zone formation between original and conservation mortars. The next step was the design of a bio-stimulating crack-sealing agent, a two-component liquid system: bacteria culture *Sporosarcina pasteurii* DSM 33 and nutrients. Both historical and conservation mortar samples were used in order to study their potentials for bio-stimulated surface-crack repair. The experiment lasted for 150 days, allowing the ureolytic bacteria *Sporosarcina pasteurii* DSM 33 to induce the precipitation of calcium carbonate into cracks and heal the damaged surface of the tested materials. The healing phenomenon was continuously monitored during a period of 150 days. Special attention

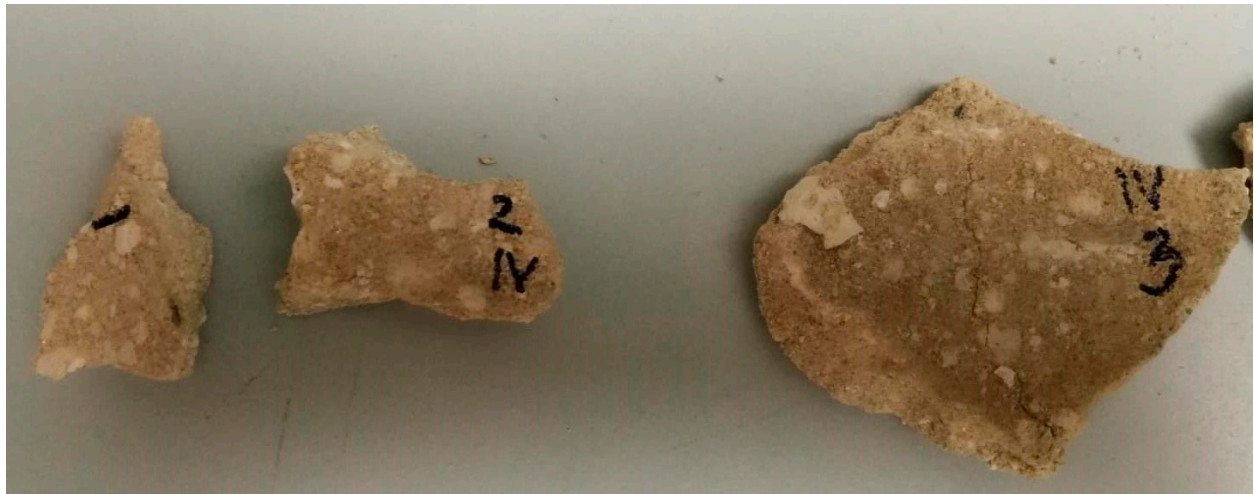
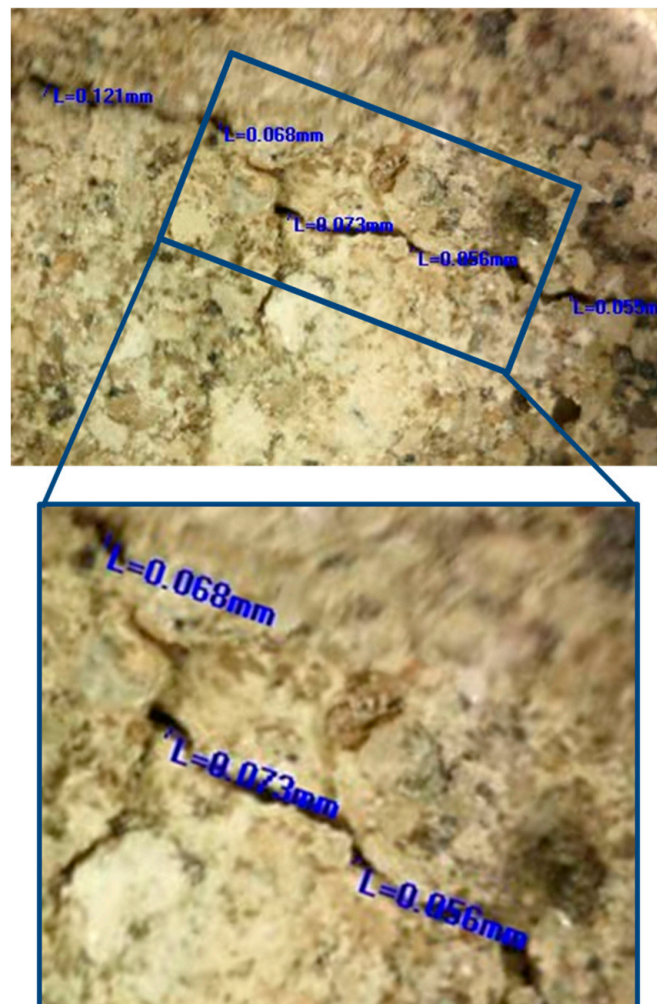
**Figure 1.** Original mortar: (a) photo of the sampled materials; (b) example of microscopic images of the cracks in original walls (measured crack width: 0.121 mm; 0.068 mm; 0.073 mm; 0.056 mm; 0.059 mm; average 0.075 mm).

More than 30 small samples (approximately several cm in diameter) with irregular shapes and a diversity of surface cracks with varieties in their width were sampled, as shown in Figure 1a. These samples were the materials that the conservators decided to remove prior to the conservation works because they were in a very bad condition (some parts of the walls were still covered with this mortar). In order to have as realistic as possible of an approach for the bio-stimulated healing experiment, the samples were grouped based on their crack widths. The samples which were too small or unusable for the crack-healing investigation were used for other laboratory investigations. Laboratory characterisation of the historical mortar samples was performed using sieving and chemical analysis, stereo-optic microscopy, X-ray fluorescence (XRF), X-ray diffraction (XRD) and scanning electron microscopy (SEM) coupled with energy-dispersive spectroscopy (EDS). Sieving and chemical analysis (acid dissolution) of the historical samples were conducted in accordance with RILEM recommendations in order to determine the aggregate and binder ratio [6]. The basic morphological features of the historical samples were determined by optical microscopy (OMANO OMXTL/V7 Articulated Boom Microscope, Microscope LLC, Roanoke, VA, USA). The mineralogical composition of the powdered samples after sieving analysis (binder (fraction < 63  $\mu\text{m}$ ), agglomerated binder/lumps (fraction > 710  $\mu\text{m}$ ) and aggregate (710–63  $\mu\text{m}$ )) was determined by XRD analysis with a PHILIPS PW 1050 Diffractometer (Philips, Netherlands) with a Cu-K $\alpha$  radiation source. The elemental analysis (XRF) was performed directly on the samples' surfaces without any preparation. These measurements were performed with a BRUKER  $\mu\text{XRF}$  ARTAX 200 system (Bruker Nano GmbH, Berlin, Germany) using a Rh radiation source, 25 kV and 1.5 mA under a He atmosphere. SEM measurements were performed after 28 days of incubation using a JSM-5500LV (JEOL, Tokyo, Japan) device and after 150 days of incubation using a JSM-6460LV (JEOL, Tokyo, Japan) device. None of the examined samples were previously sputter-coated with gold.

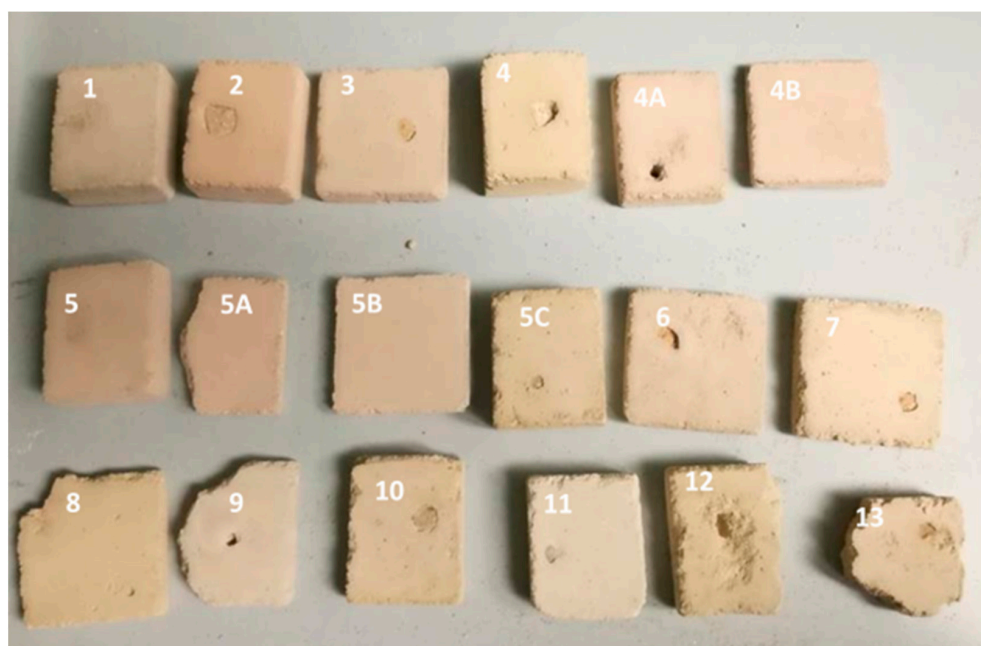
**Figure 2.** Photo of the laboratory-prepared MM samples after artificial ageing, Table 1.

Based on the results, the most promising model mortar (MM) was selected for conservation purposes (Table 1, Figure 2 marked as sample 5B) [6]. The composition of this mortar mixture was as follows: binder-to-aggregate volume ratio of 1 to 2 (slaked lime 1, crushed brick 0.2 as pozzolanic material, river sand 1.6 and milled limestone 0.2). This mixture was considered to be compatible since it exhibited lower a value of the average drilling force compared to the original historical mortar (HM) [4]. The total colour difference between the selected MM and HM ( $\Delta E = 0.94$ ) was lower than 3, which meant that the MM was visually highly compatible with the HM (the difference could not be detected with the naked eye) [18]. Moreover, the individual colour coordinates for the MM sample were approximately the same as that of HM (Table 4).

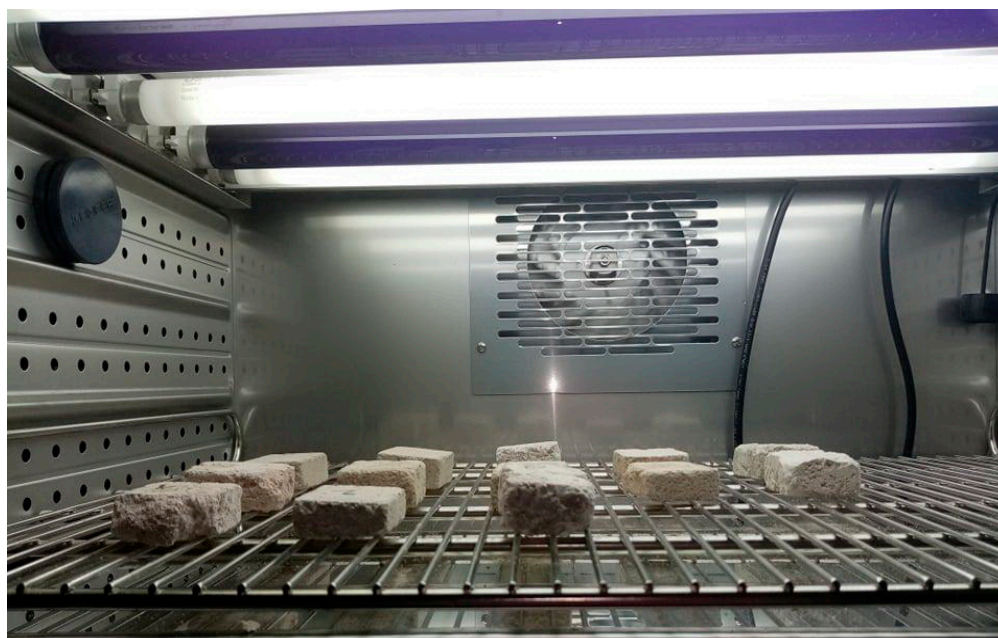
**Figure 3.** Artificial ageing of the MM mortar samples in the chamber.

The artificial ageing procedure was set up based on the average climatic parameters in Serbia, relevant scientific publications, our previous experience and an already proven methodology for the design of compatible systems [4,6]. In the first 5 days, the MM samples were exposed to room conditions ( $T = 20\text{ }^{\circ}\text{C}$  and  $\text{RH} = 60\%$ ), after which they were placed in a climate chamber for one month, combining exposure to high and low temperatures and different relative humidities ( $T = 30\text{ }^{\circ}\text{C}$  and  $\text{RH} = 80\%$  for 5 days,  $T = 0\text{ }^{\circ}\text{C}$  and  $\text{RH} = 60\%$  for 24 h, repeated for 5 cycles in total). Then, the MM samples were again subjected to room conditions for 7 days. After the artificial ageing in laboratory (Figure 3), the MM samples were analysed.

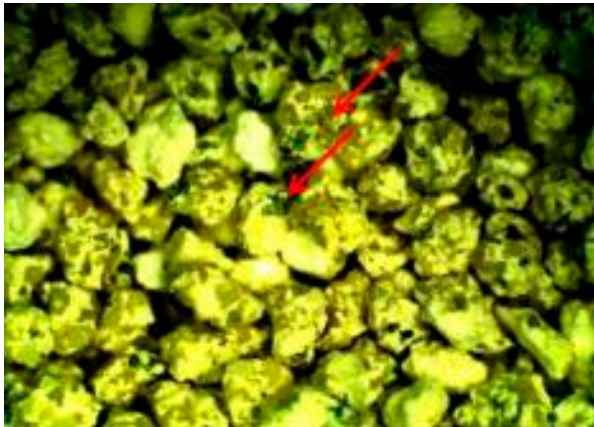
Fraction 1000–710  $\mu\text{m}$   
Agglomerated binder fraction;  
magnification  $\times 45$

Based on the sieving and microscopic analyses (Table 2), it was revealed that the fractions larger than 710  $\mu\text{m}$  represented agglomerated binder/lime lumps and the particles in the size interval 710–63  $\mu\text{m}$  clearly indicated the morphology and colour characteristics of sand and crushed bricks, whereas the fraction smaller than 63  $\mu\text{m}$  represented solely the binder. Based on the obtained results, the binder-to-aggregate ratio of the historical sample was calculated, while the chemical analyses (treatments with hydrochloric acid and sodium carbonate) determined the mass percentage of the sand and the crushed bricks in the aggregate.

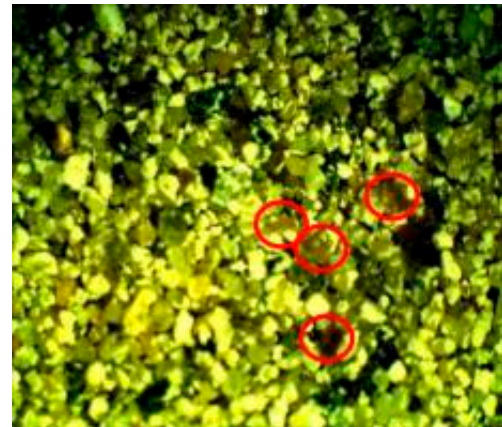
Fraction 250–125  $\mu\text{m}$   
Crushed brick particles marked;  
magnification  $\times 20$

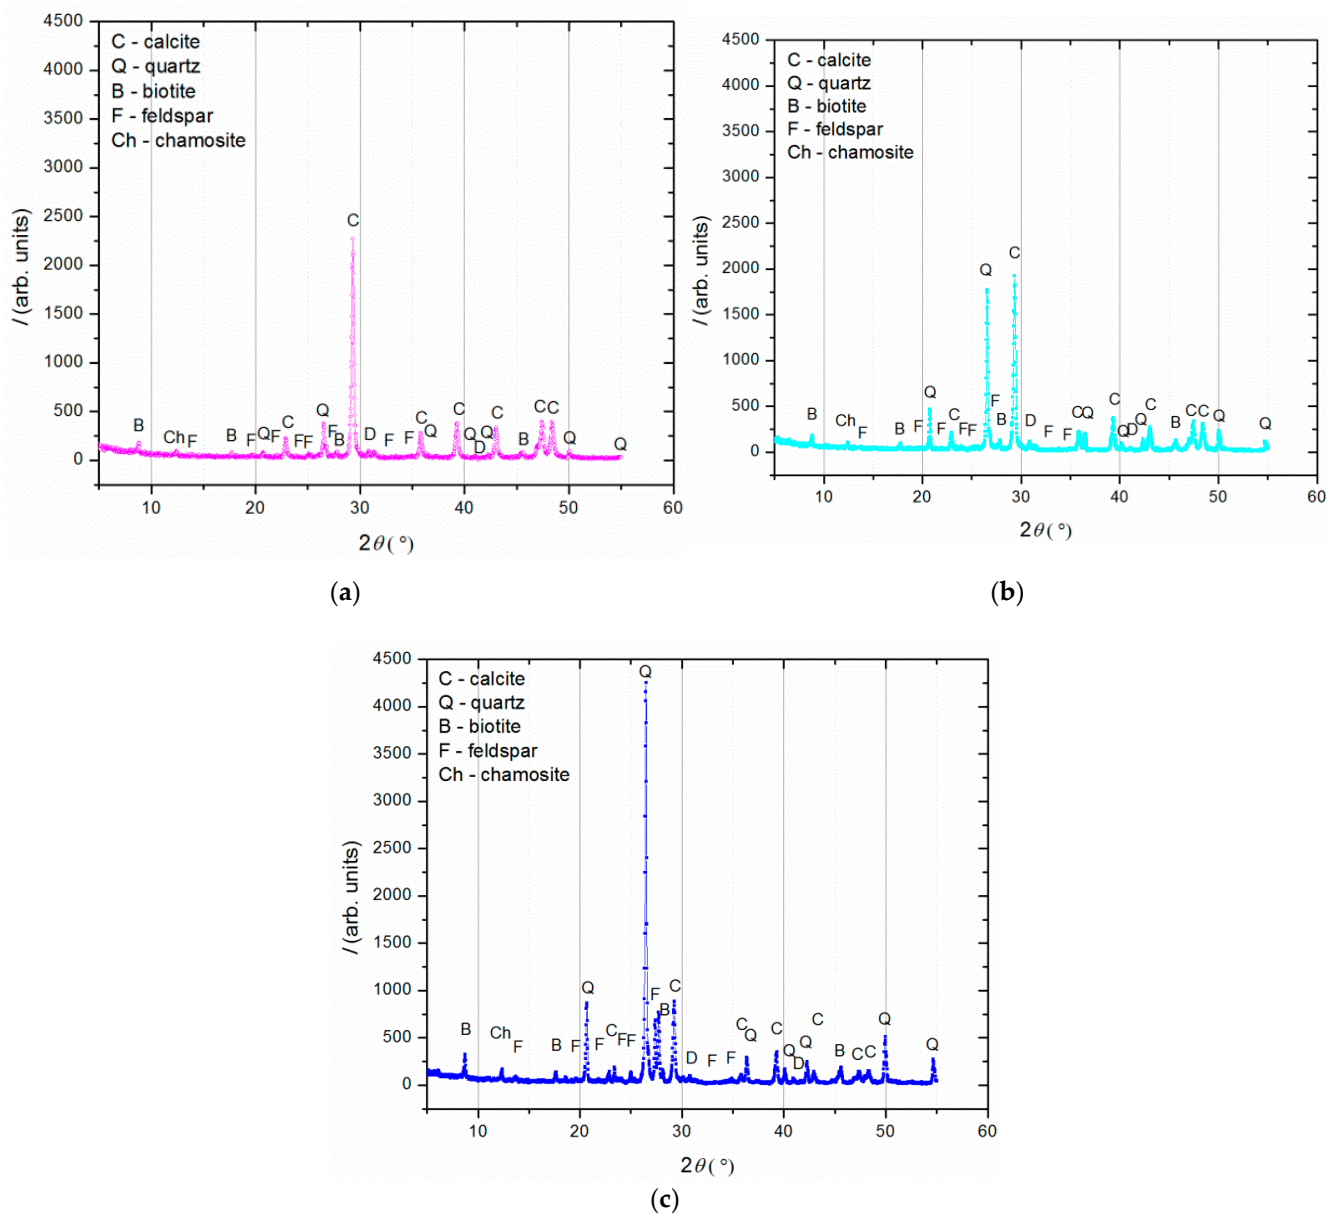
**Figure 4.** XRD analysis of (a) binder (fraction < 63  $\mu\text{m}$ ); (b) agglomerated binder/lumps (fraction > 710  $\mu\text{m}$ ); (c) aggregate (710–63  $\mu\text{m}$ ).

XRD analysis (Figure 4) was performed on three separated fractions: (a) binder,  $<63 \mu\text{m}$ , (b) agglomerated binder,  $>710 \mu\text{m}$  and (c) aggregate,  $63\text{--}710 \mu\text{m}$ . In the case of the examined fractions, the following mineral crystalline phases were detected: calcite [ $\text{CaCO}_3$ ], quartz [ $\text{SiO}_2$ ], biotite [ $(\text{K}(\text{Mg},\text{Fe})_3(\text{AlSi}_3\text{O}_{10})(\text{F},\text{OH})_2)$ ], feldspar [ $\text{KAlSi}_3\text{O}_8\text{--NaAlSi}_3\text{O}_8\text{--CaAl}_2\text{Si}_2\text{O}_8$ ] and chamosite [ $(\text{Fe}_2,\text{Mg})_5\text{Al}(\text{AlSi}_3\text{O}_{10})$ ]. In the case of the binder fraction ( $<63 \mu\text{m}$ ), as expected, a significantly higher proportion of calcium carbonate (calcite) was identified, while in the case of the aggregate fraction ( $710\text{--}63 \mu\text{m}$ ), a dominant presence of quartz was found. The identified calcite in the aggregate fraction was a consequence of limestone being used for the historical mortar preparation. The identified biotite was more significant in the case of the aggregate in relation to the binder fraction, which was expected since this mineral is usually present in river sands. Additionally, the slightly higher intensity of the identified chamosite in the aggregate relative to the binder fraction was a consequence of the already-identified particles of the crushed bricks. Finally, in the agglomerated binder/lumps (fraction  $>710 \mu\text{m}$ ), the dominant mineral form, namely calcite, corresponded well to the composition of the binder fraction ( $<63 \mu\text{m}$ ) except for the presence of quartz, which was intercalated in the agglomerated binder/lumps.

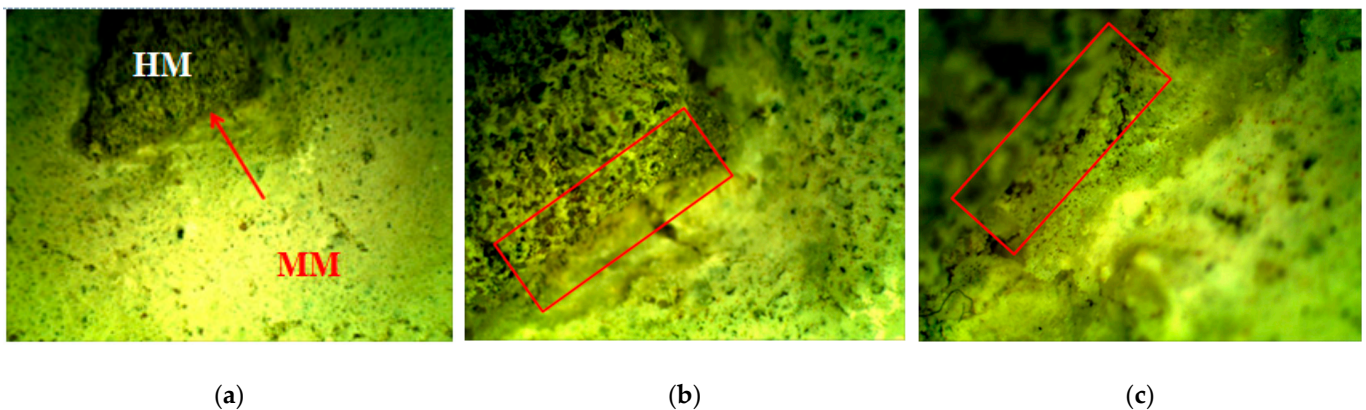
**Figure 5.** Stereo-optical microscopy: marked contact zone formation between original HM and chosen new mortar MM, magnification: (a)  $\times 6.5$ ; (b)  $\times 20$  and (c)  $\times 40$  [6].

The mutual interaction and cohesion between the original historical mortar (HM) and the laboratory-prepared conservation mortars (MM) was studied. A small fragment of the HM sample was put inside the most-promising new MM sample, as shown in Table 4. The interaction between the two samples was studied by using a stereo-optical microscope. During the carbonation/hydration process, a contact zone without cracks was formed between the original (HM) and the new (MM) sample. The morphology investigation, as shown in Figure 5, of the contact zone showed that the formed area had a satisfactory appearance (without cracks) [6,21].

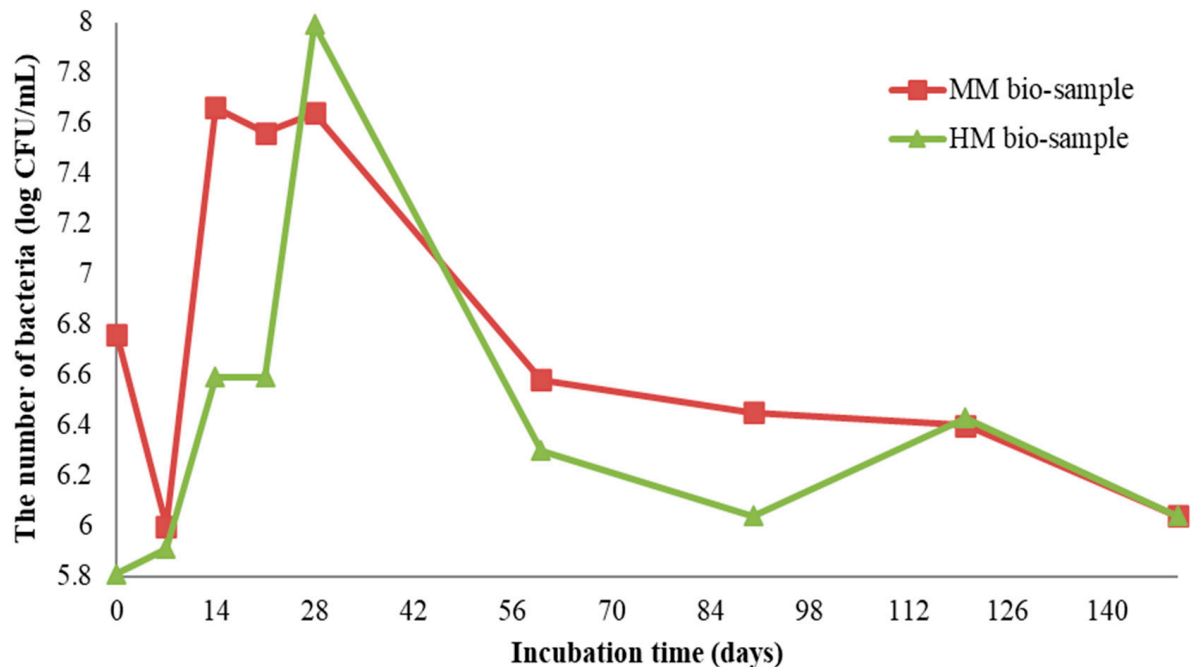
Figure 6. Enumeration of *S. pasteurii* DSM 33 on MM and HM bio-samples [6].

The growth profiles of *S. pasteurii* DSM 33 on the HM and MM bio-samples are shown in Figure 6. The initial number of bacterial spores of *S. pasteurii* DSM 33 in the suspension was  $8.3 \log \text{CFU/mL}$  (CFU—colony-forming unit). After the application of  $100 \mu\text{L}$  of suspension onto/into the crack, the number of bacterial cells was above  $5.8 \log \text{CFU/mL}$ , dependent on the sample type (HM or MM). Within the first two months of incubation, the concentration of the cells was increased by at least  $2 \log \text{CFU}$  units. Decreasing trends for both the bio-samples were observed at the end of the incubation period. At the end of the experiment, the concentration of vegetative cells of *S. pasteurii* DSM 33 was above  $6 \log \text{CFU}$  units. According to the obtained results shown in Figure 6, it can be suggested that the observed concentration of vegetative cells could sustain the MICP process. Although the number of bacteria varied with time, it could be clearly concluded from Figure 6 that the cell concentration did not go below  $6 \log \text{CFU/mL}$ , even after 140 days. This number of cells was more than enough to encourage and sustain the MICP process and induce the precipitation of crystal forms in the crack zone during the experiment time [22].

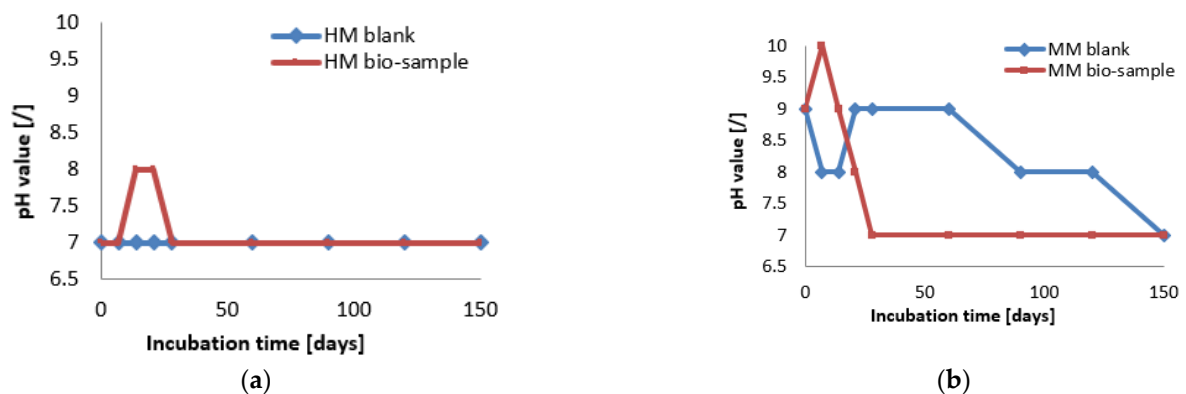
Figure 7. The pH monitoring of HM samples (a) and MM samples (b) [6].

At the start of the experiment, the HM samples had a lower pH value (approx. 7), while the MM samples were in the alkaline zone (approx.  $\text{pH} = 9$ ). The mentioned pH values were in the pH zone for the bacterial growth and ureolytic activity of *S. pasteurii* (7–10) [20]. In the case of the HM samples, the pH value of the bio-sample did not change within the first 7 days, which was in correlation with the log (initial) growth phase of *S. pasteurii*. After the initial stagnation, the pH value of the HM bio-sample increased, suggesting the start of ureolytic activity. During the next 21 days, the pH value and the number of vegetative cells showed increasing trends (Figures 6 and 7a). Besides a further increase in the vegetative cell number, the pH value of the HM bio-sample did not follow this trend and dropped to the initial pH value. These results suggested that ureolytic activity started, but the bacteria-induced precipitation slowed down due to the lack of free calcium ions in the historical samples. Moreover, it might be concluded that the ureolytic

In the case of the MM samples, the pH value change in the bio-samples followed a trend similar to the bacterial viability, as shown in Figure 7. After a short decreasing period at the start, the pH value reached the initial level, and this value was maintained until 60 days of incubation. Due to a decrease in number of vegetative cells, pH value of the MM bio-sample also decreased until the end of incubation, reaching a final value of 7, as shown in Figure 7b. The HM blank sample remained stable during the incubation period, while the MM blank sample was affected by the continuous hydration process and had steep changes as well as a lower final pH value compared to the initial value.

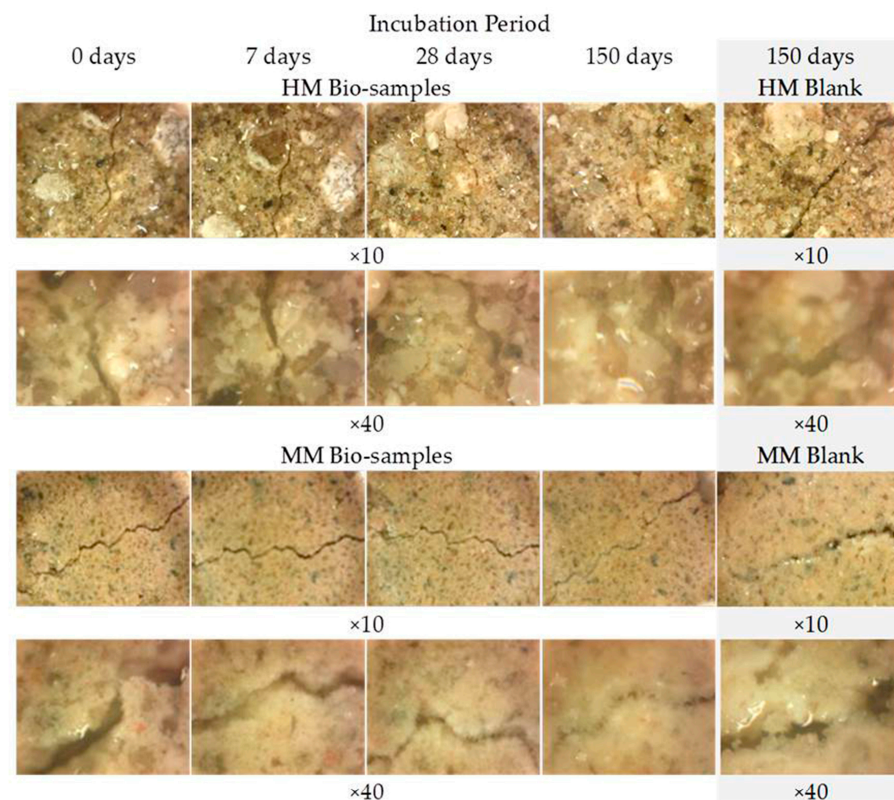
**Figure 8.** Microscopic images of HM and MM bio- and blank samples [6].

The images obtained by the digital optical microscope in the different phases of the experiment (0 days, 7 days, 28 days, 150 days) visibly indicated that the crack repair process was indeed obtained in the HM and MM bio-samples (Figure 8).

Comparing the microscopic images of the HM and MM bio-samples with the HM and MM blank samples after 150 days, the surface-crack repair of the MM bio-samples was more pronounced and visible, as shown in Table 5 (the growth of needle-like crystals from the crack edges was identified). This could be explained by the fact that in the case of model mortars (MM) there were more calcium ions available for the bio-stimulated calcium carbonate precipitation, as at the time of the experiment, carbonization was still an on-going process. In the case of the historical bio-samples, the crack widths were similar or slightly lower compared to the original samples, and there was not a big difference in the closure ratio between 28th and 150th days of the experiment. Evidently, in the case of the “mature mortars”, much more than bio-stimulated carbonate sprouts is needed for the crack-healing process after 28 days. These results were in agreement with the results shown in Figures 6 and 7. Namely, the ureolytic activity started, but the bacteria-induced precipitation slowed down due to a lack of free calcium ions in the historical samples. In order to obtain more information about the crack-repair effects in the case of the MM bio-samples, an SEM investigation was applied, while the historical samples were not examined further.

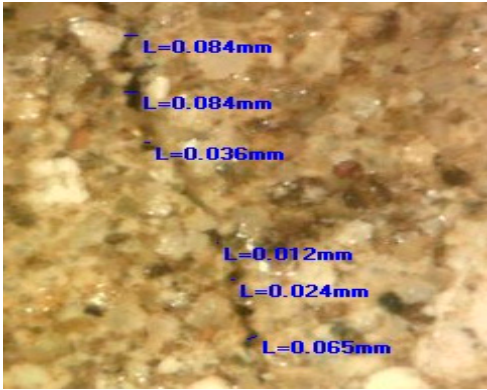
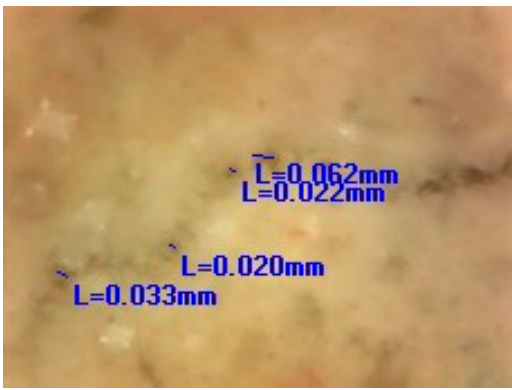
150 days HM sample			150 days MM sample

Sample	HM Bio-Samples		MM Bio-Samples	
0 days, crack width, mm	Measured	0.045; 0.67; 0.045; 0.115; 0.090; 0.067	Measured	0.070; 0.094; 0.071; 0.098; 0.091; 0.085;
	Average	0.0715	Average	0.084
150 days, crack width, mm	Measured	0.084; 0.084; 0.036; 0.012; 0.024; 0.065	Measured	0.033; 0.020; 0.022; 0.062;
	Average	0.051	Average	0.034
Magnified detail of the measurement position

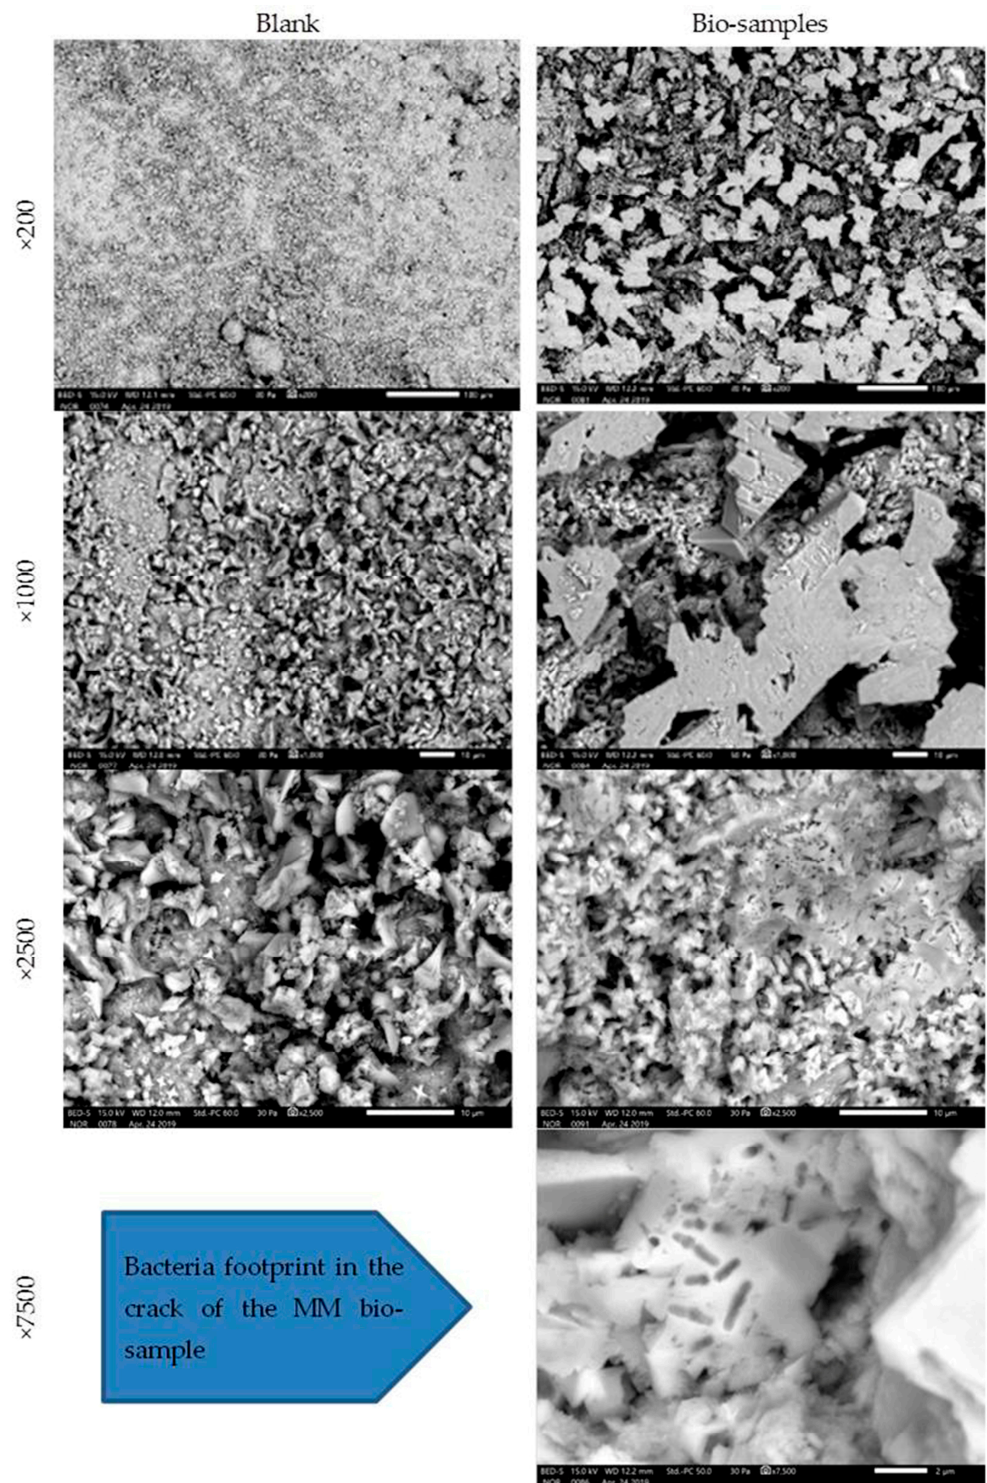
Figure 9. Microscopic images of MM bio- and blank samples after 28 days of incubation [6].

The MM bio-samples and blanks were analysed on the 28th day of incubation (Figure 9).

The obtained SEM images revealed evidence about the nature and structure of the precipitate. In the SEM images, the difference was easily observed between the blank and bio-samples of the MM after 28 days of incubation. The difference was in the clearly detectable presence of  $\text{CaCO}_3$  crystals in the precipitate of the bio-samples. Under a magnification of  $\times 7500$ , the image of the MM bio-sample revealed a bacterial footprint (impressions) in the designed crack.

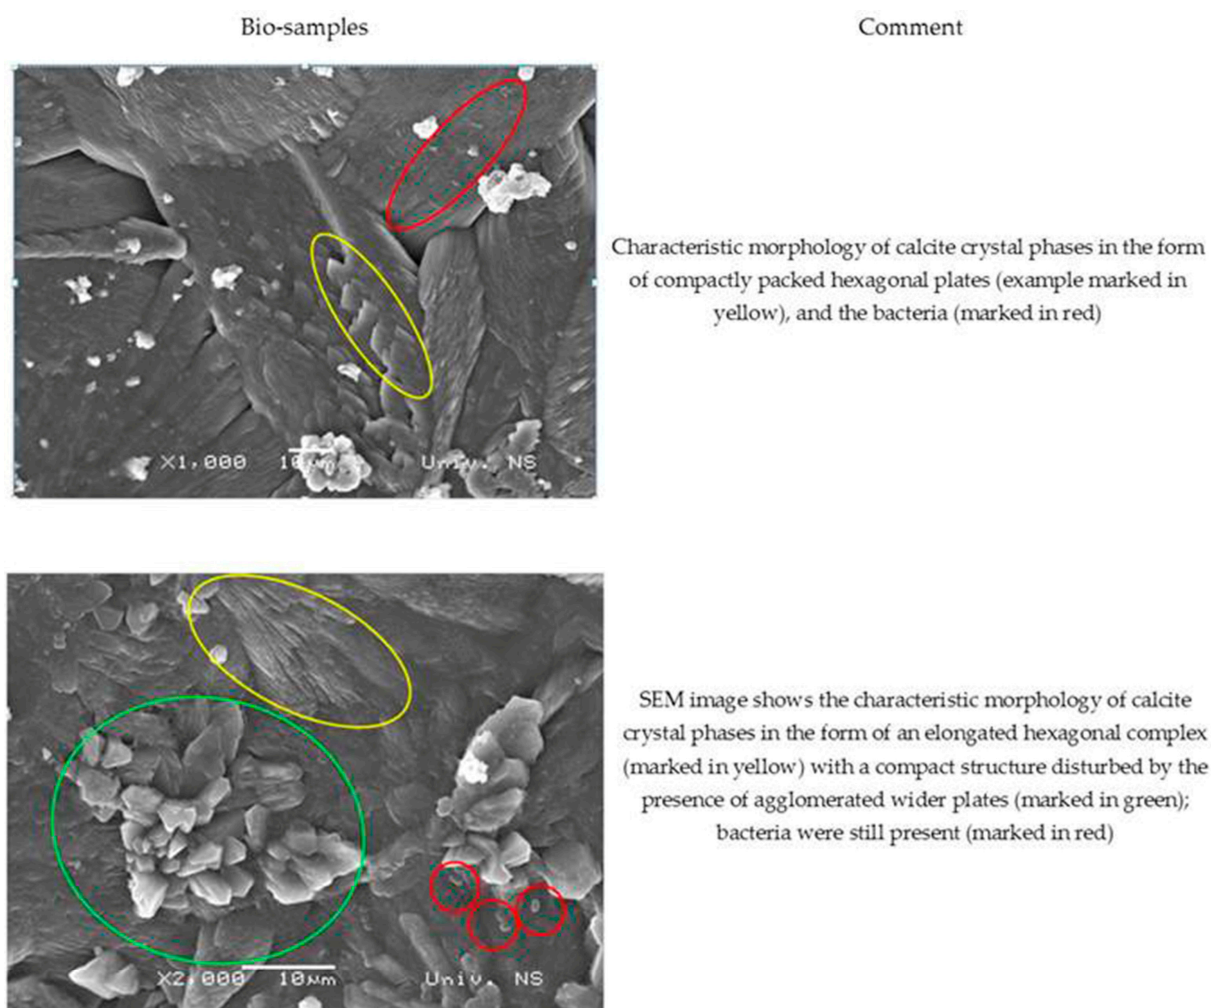
**Figure 10.** SEM analysis of MM bio-samples (precipitate formed in cracks) after 150 days of incubation [23].

The SEM images of the MM bio-samples after 150 days of incubation (Figure 10) reveal the effects of the advanced bacteria-stimulated formation of calcium carbonate in the cracks.

As shown in Figure 10, the SEM images of the MM bio-samples indicated the morphology of the surface crystal structures. The footprints of vegetative cells were not observed at the surface of the MM bio-samples. On the other hand, a sporogenic bacterial form (marked in red in both pictures) was detected around the already-formed  $\text{CaCO}_3$ . Evidently, the identified bacterial spores stayed inactive from the beginning of the incubation period, and  $\text{CaCO}_3$  precipitation became a more important factor with increasing age in the humid environments.

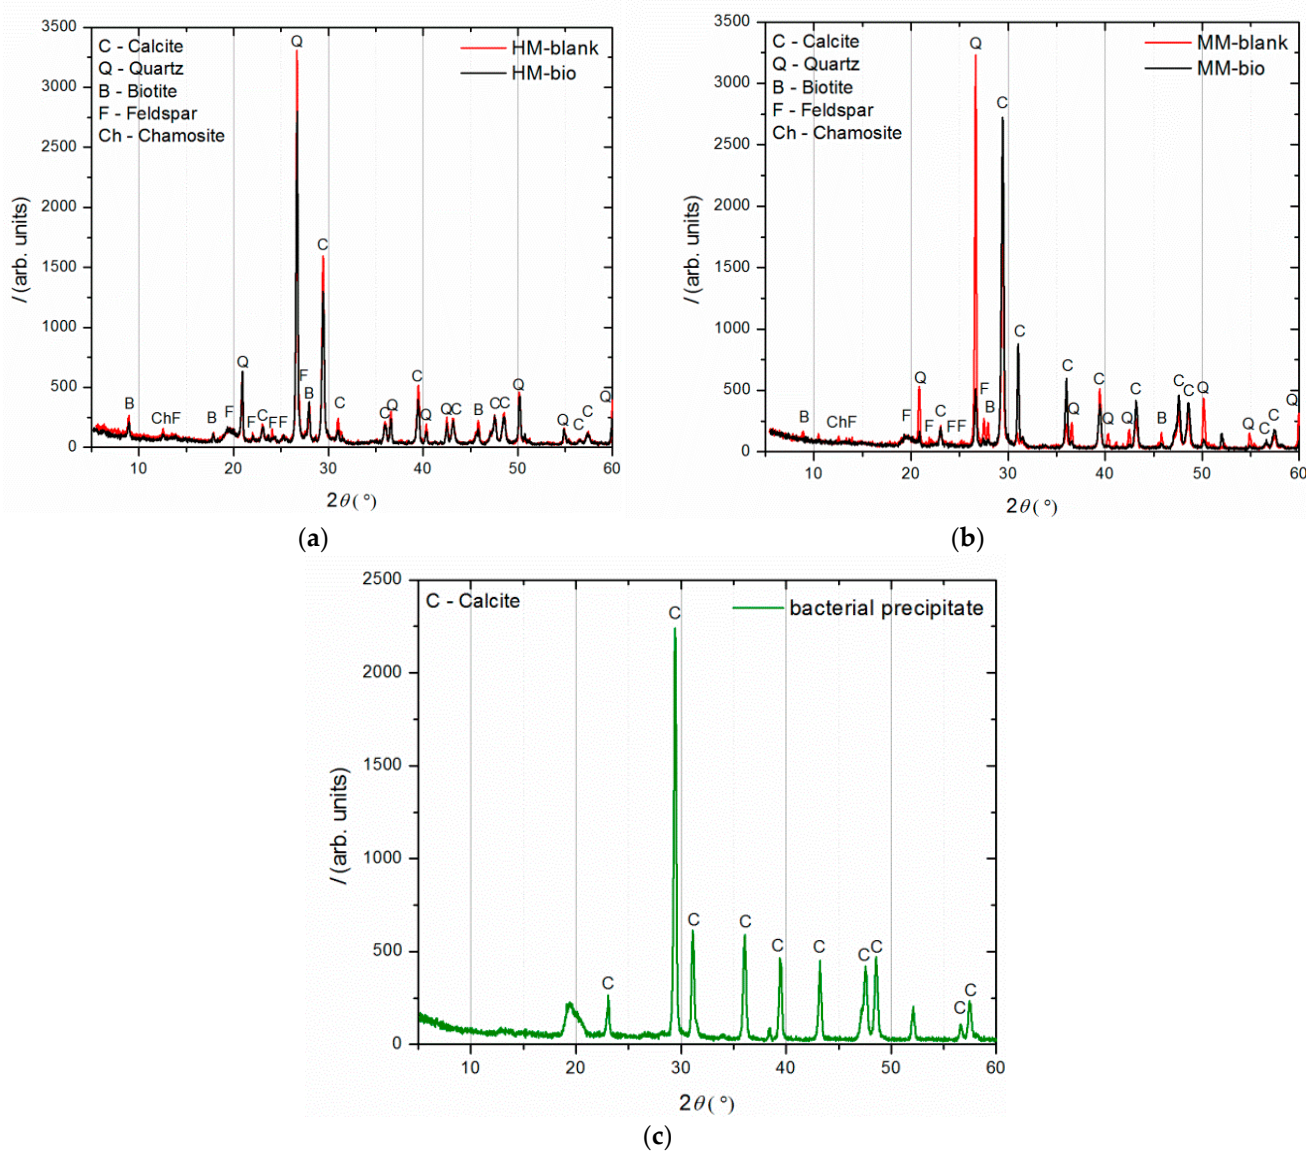
**Figure 11.** XRD analysis after 150 days of incubation: (a) HM blank and HM bio-samples comparative results, (b) MM blank and MM bio-samples comparative results, (c) sole bacterial precipitate.

The phase composition of the historical and model blank and bio-samples was examined by XRD analysis after 150 days of incubation. For each sample, the material subjected to these measurements was collected from the crack area in order to determine the crystalline structures formed during the healing process. Figure 11a shows the diffractograms of the historical mortars (HM blank and HM bio-sample), plotted together for comparison. Similarly, the XRD patterns belonging to the model mortars (MM blank and MM bio-sample) are shown in Figure 11b, while the pattern of the sole bacterial precipitate, taken from the MM bio-sample, is shown in Figure 11c.

Comparing the XRD patterns of HM blank and HM bio-samples (Figure 11a), there were no significant differences except for the intensity of all the diffraction peaks being reduced for the HM bio-sample. In contrary to this, comparing the MM blank and MM bio-samples (Figure 11b), the MM blank sample had a much higher quartz maxima than the MM bio-sample, while the MM bio-sample had a much more intense calcite maxima in comparison to the MM blank sample. This implied that strong calcite precipitation occurred in the MM bio-samples, in the region of the crack-healing area.

The comparison of the obtained results between the HM bio- and MM bio-samples confirmed that the bacteria-induced precipitation was limited in the HM samples because of the lack of free calcium ions. Namely, the “young” mortars with incomplete carbonation, as it was the case with the MM bio-samples, which were exposed to wet conditions, had a suitable quantity of free calcium ions inside ready for the healing processes [24]. The XRD analysis of the sole bacterial precipitate showed the presence of pure calcite, which confirmed that the increase in the calcite content in the healed MM bio-sample was a consequence of the bacterial activity. The unassigned peaks in Figure 11c belonged to the
